Abnormal Noise From the AWD Dynamic Torque Vectoring Disconnect System

Service Category Drivetrain

Section Axle/Differential

YEAR(S)	MODEL(S)	ADDITIONAL INFORMATION
2019 - 2020	RAV4	VDS(s): J1RFV, N1RFV

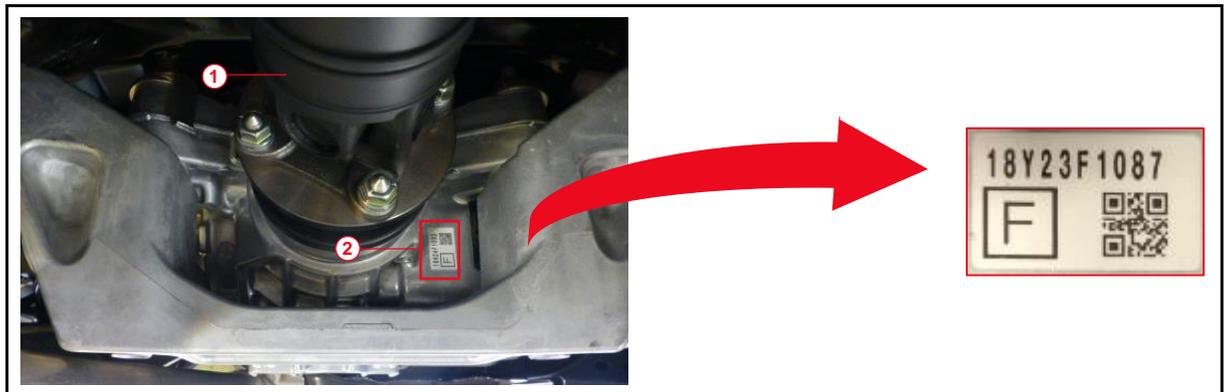
Figure 1. Rear Differential Carrier Assembly Differential Front View

1. Locate the rear differential carrier assembly serial number, as shown in the figure below.

1	Propeller Shaft
2	Rear Differential Carrier Assembly Serial Number

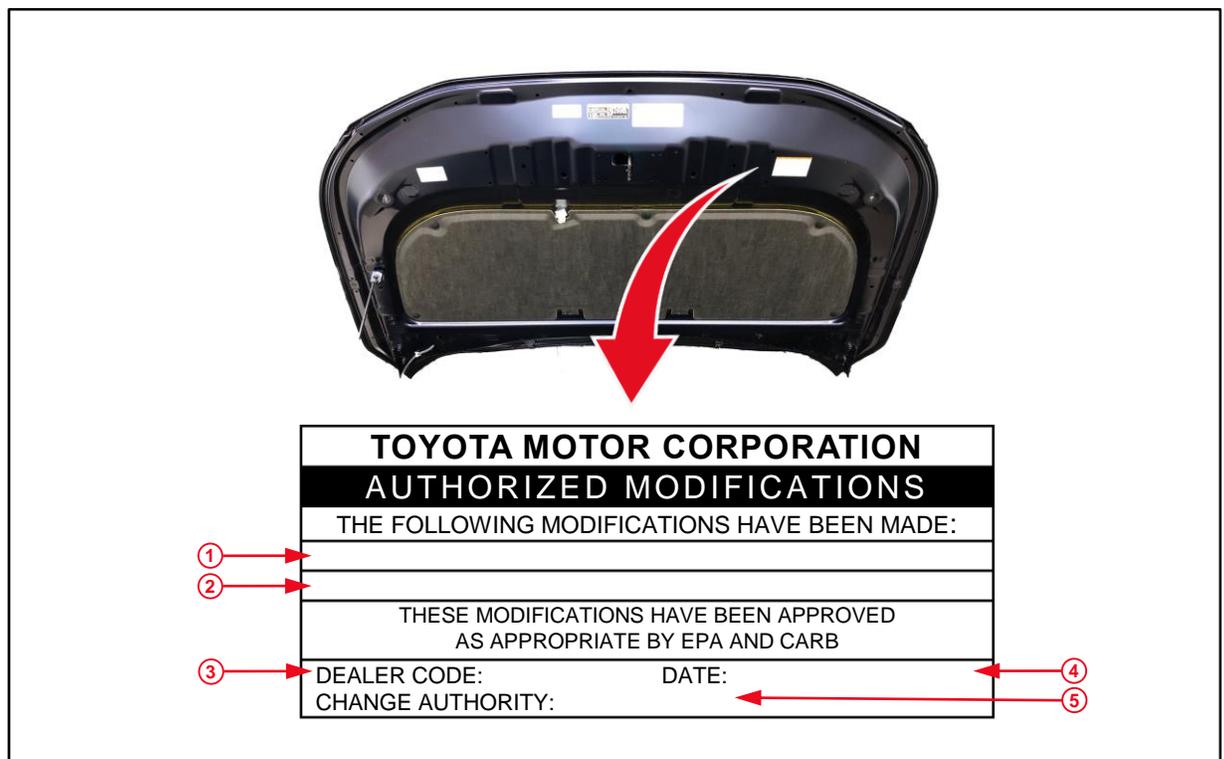
Figure 4. Location of Authorized Modifications Label on 2019 – 2020 RAV4

1. Use Techstream to confirm if the 4WD ECU calibration has been updated and check for the Authorized Modifications Label affixed to the vehicle in the location shown below.
Is the calibration ID listed in Techstream and on the label the latest 4WD ECU calibration?
 - **YES** — Go to step 4.
 - **NO** — Continue to step 2.

1	Replacement ECM (PCM) Part Number (e.g., 89630-42161)
2	New Calibration ID (e.g., F15364212000)
3	Dealer Code

4	Date Completed
5	This SB Number

- Prepare and install the Authorized Modifications Label.
 - Using a permanent marker, enter the following information on the label:
 - 4WD ECU part number [Refer to the **Parts Information** section for the **NEW PART NUMBER**]
 - Calibration ID(s) [Refer to the **Calibration Information** section for the **NEW CALIBRATION ID**]
 - Dealer Code
 - Repair Date
 - Change Authority [***This bulletin number***]
 - Install the Authorized Modifications Label onto the vehicle at the location shown in Figure 4. The Authorized Modifications Label is available through the MDC, P/N 00451-00001-LBL.
- Using Techstream, check for and clear ANY DTCs.
- Test-drive the vehicle and confirm the condition no longer exists.
